Technical Report GL-97-4
April 1997

Contingency Airfield and Road Construction Using Geosynthetic Fiber Stabilization of Sands

by Steve L. Webster, Rosa L. Santoni

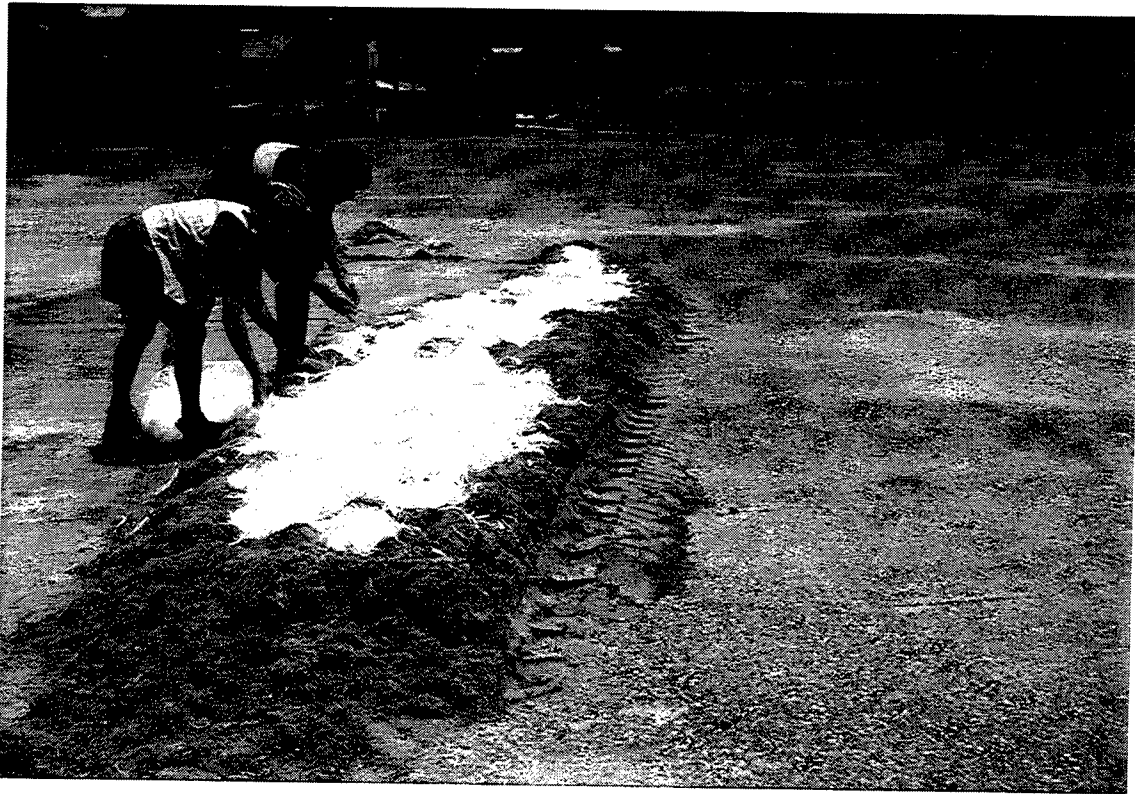
Figure 3. Monofilament fibers on sand surface

Field mixing experiments were conducted to see if the fibers could be uniformly mixed in sand using standard existing military construction equipment. Figures 3 to 6 show the field mixing procedure using the standard Army self-propelled rotary mixer.

The field mixing procedure consisted of spreading the fibers on the sand surface and making repeated passes with the rotary mixer as shown in Figures 3 and 4. Visual observations indicated that four passes were required to separate the yarn into individual fibers and uniformly mix them throughout the sand layer. Figures 5 and 6 show the uniformity of the sand-fiber mix after four passes with the self-propelled rotary mixer.

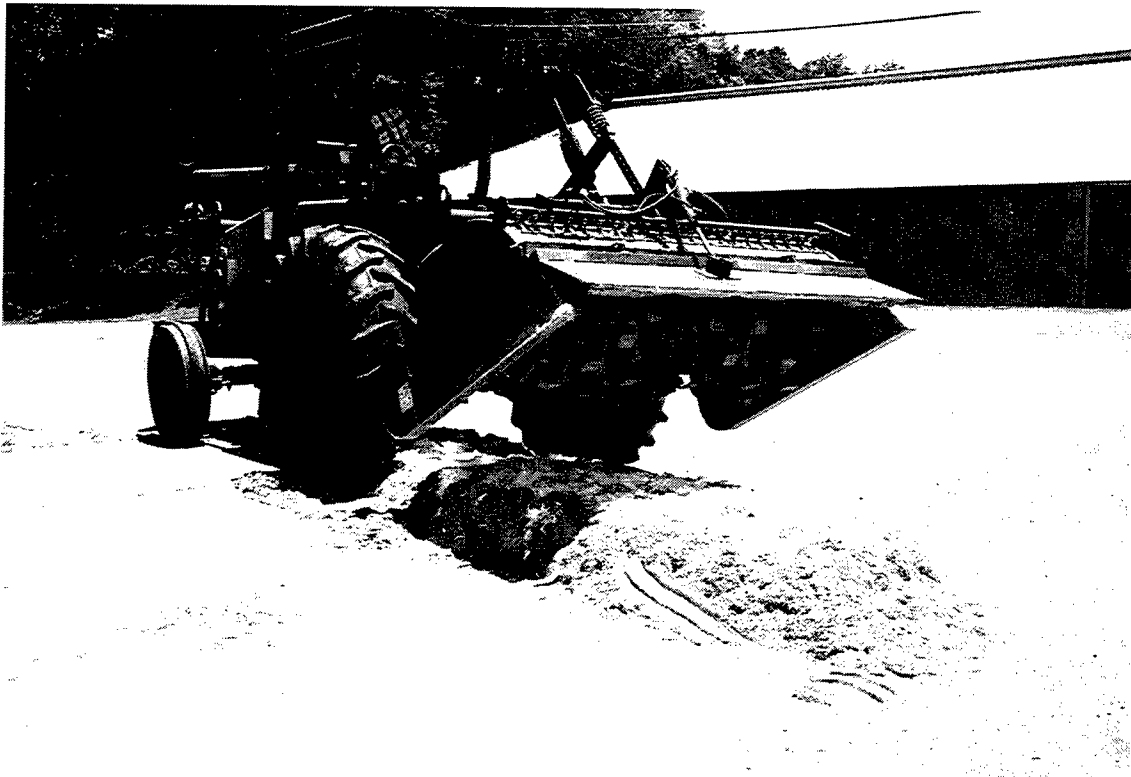
Figure 4. Field mixer equipment

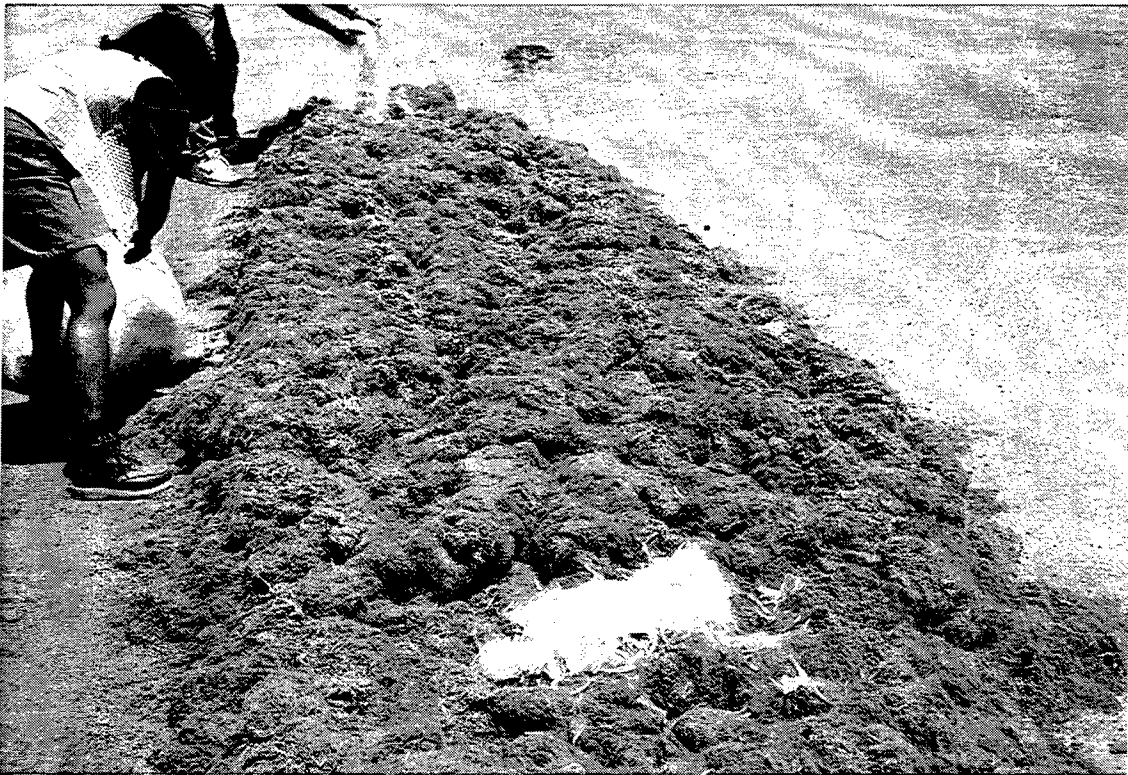
Figure 5. Fiber mixed in sand after four passes

The field mix of sand and fibers consisted of 3,600 lb of moist concrete sand (SP). The sand had an average moisture content of 6 percent. The amount of fiber used was 80 lb which was 2.4 percent (based on dry weight of the sand) of fiber in the mix. A total of 80 lb of fiber (2.4 percent based on dry weight of the sand) was mixed into the sand. First, 0.2 percent of the fiber was mixed into the sand using four passes of the mixer. The fiber content was then increased to 0.5, 1, and finally 2.4 percent. In all the cases, the fibers in the field mixed material looked very uniformly distributed after four passes of the mixer.

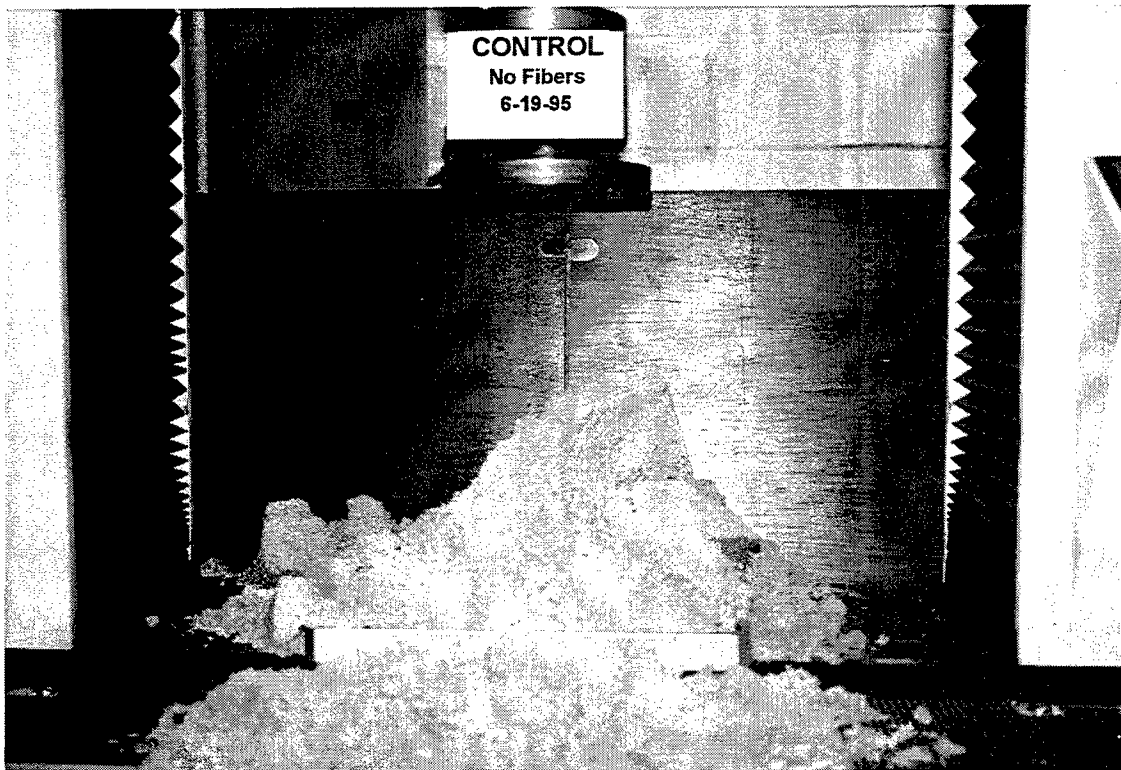
Figure 10. Control sample after 9.67-lb load

Figures 9 and 10 show the control sample (no fibers) before loading and after loading. The control sample collapsed under a load of 9.67 lb.

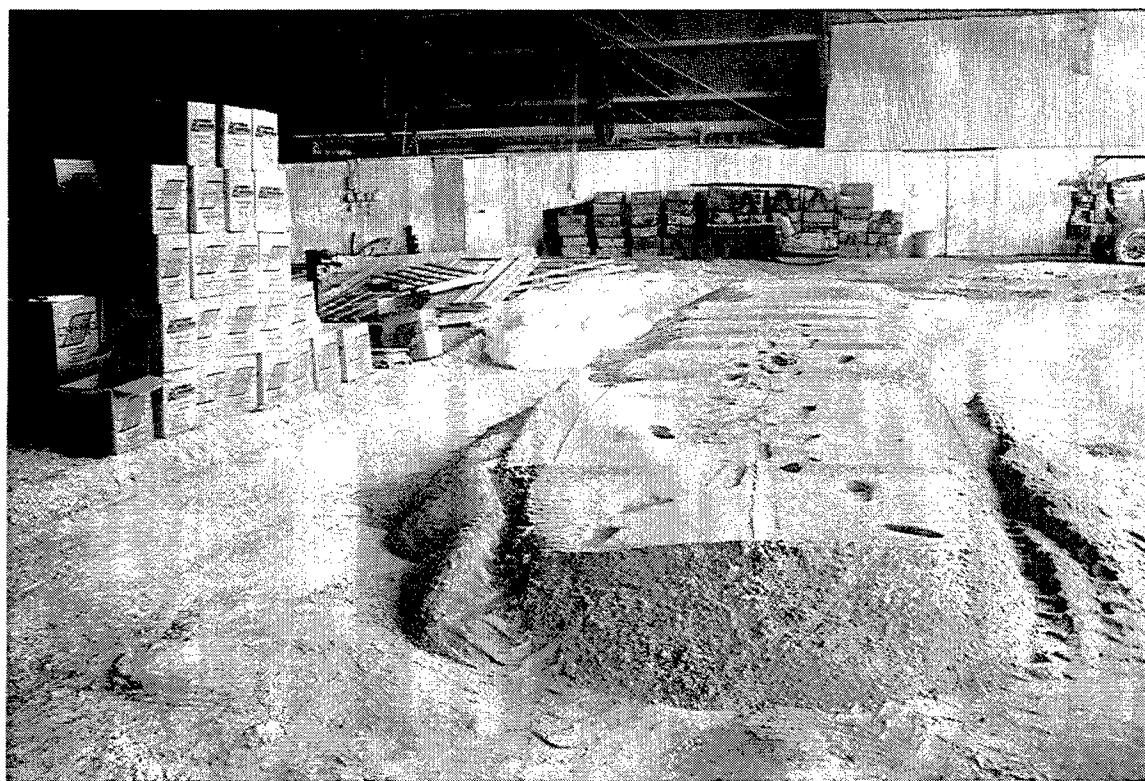
Figure 24. Sand for typical item, prior to adding fibers

The sand-fiber mixture used in items 1, 2, 4, and 5 was mixed at a working area adjacent to the test section site. After mixing, the sand-fiber material was installed and compacted in the test section. Figure 24 shows the sand for one of the test items prior to adding the fiber stabilization. The moisture content of the sand was approximately 4 percent. A total of 1 percent fibers (by weight) was mixed into the sand. Figure 25 shows spreading one-half the required fibers on the sand layer. Figure 26 shows a close-up of the fibers on the sand. Each clump of fibers contained several hundred individual fibers each about the diameter of fine human hair. The fibers were mixed into the sand using 4 passes with the self-propelled rotary mixer used by U.S. Army Engineers (Figure 27). The sand-fiber layer was then turned over using a front-end-loader and the remaining fibers were placed and mixed using four passes of the rotary mixer to ensure a uniform sand-fiber mixture for the whole layer. Figure 28 shows the sand-fiber mixture after the final 4 passes with the rotary mixer. Most of the clumps of fibers had disappeared and the hair-like fibers were uniformly mixed throughout the sand.

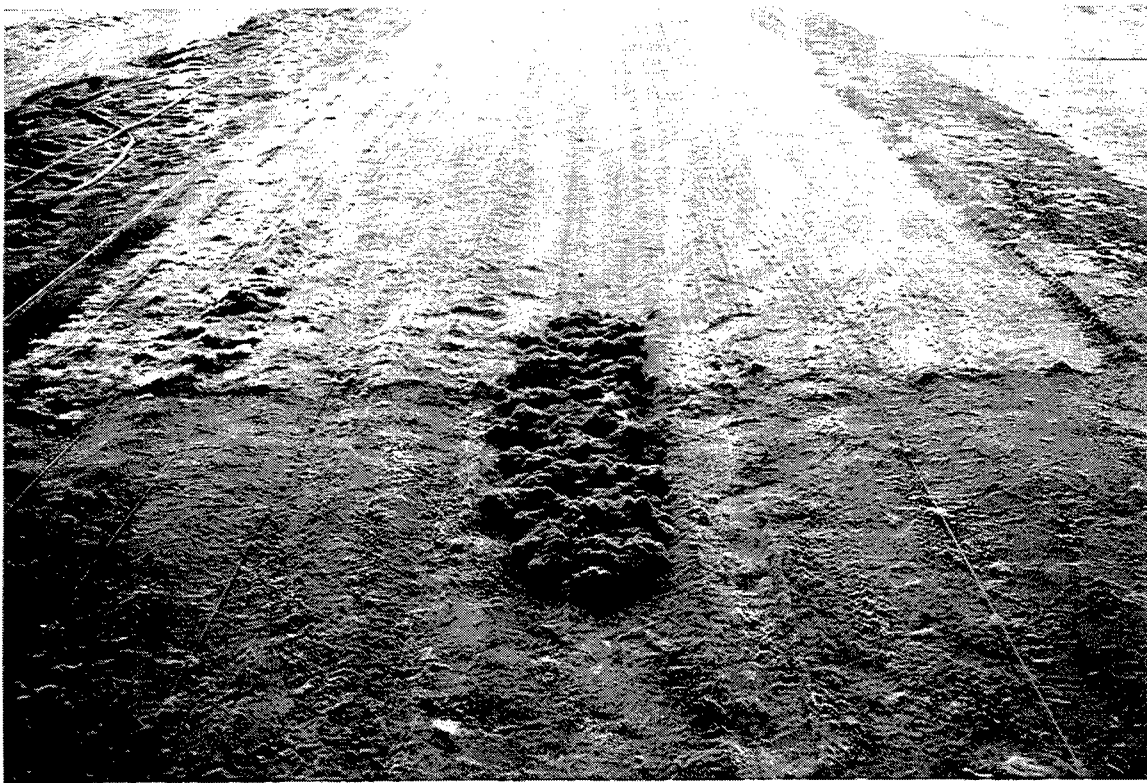
Figure 40. Patching material on small rut between items 2 and 3

Small amounts of sand-fiber (used in item 2) or sand-fiber-Road Oyl (used in items 3, 5, and 6) patching material were used to repair spot locations where 3- to 4-in. ruts developed. Figure 40 shows how some patching material was used to repair a spot rut that developed at the transition between items 2 and 3. A pitch fork worked much better than a shovel when handling the patch material. The fibers prevent a shovel from penetrating into a pile of patch material. Figure 41 shows the patched area after traffic compacted the patch. The patched area bonded with the item surface and stayed in place during additional traffic passes. Patching sand-fiber layers with like material was easy and effective.

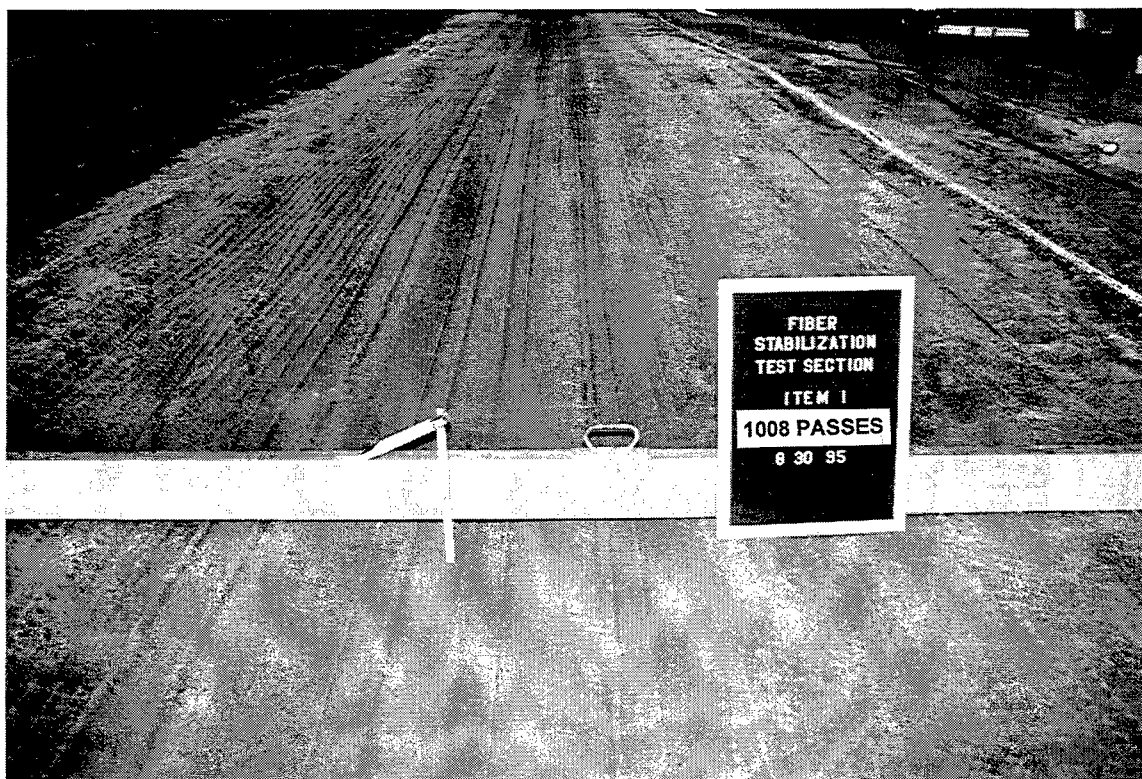
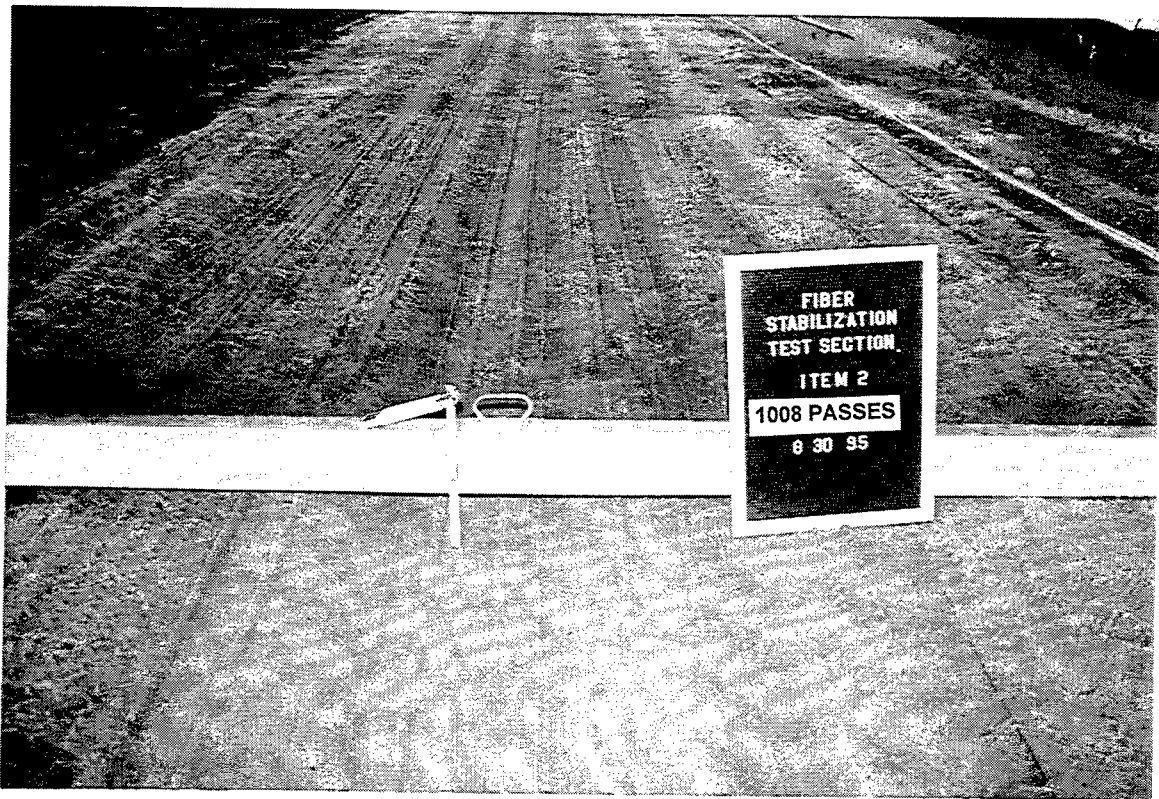
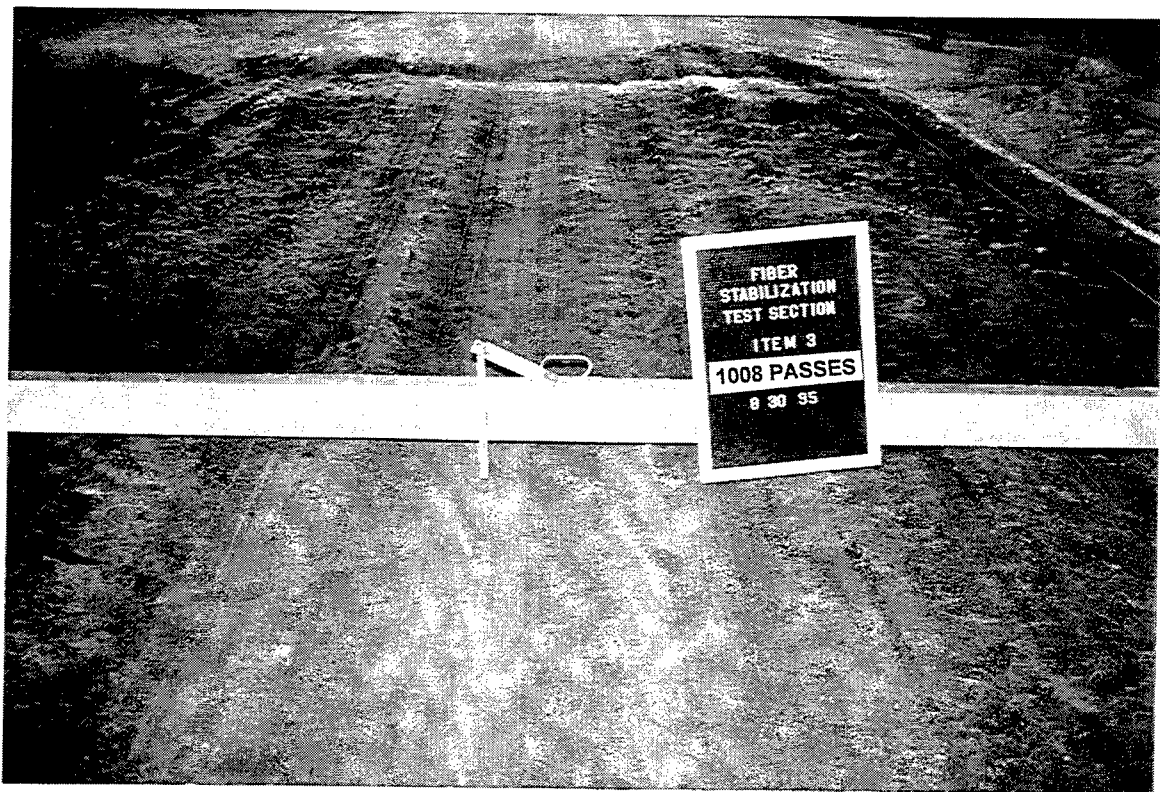
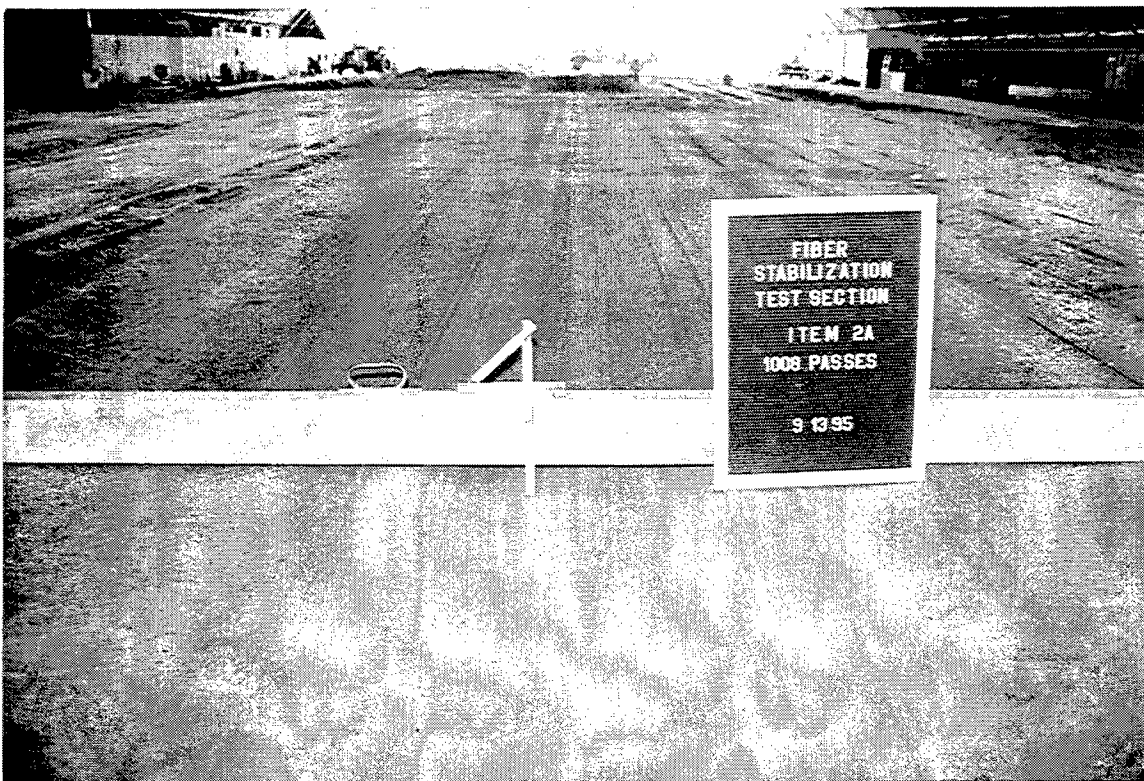
Figures 56 through 61 show the condition of each item after 1,008 passes of traffic. Even though items 1 through 3 had rutted over 3 in., their surface condition was still good with very little upheaval outside the traffic lane. The condition of items 1A through 3A was excellent after 1,008 passes. Rut depths in these items was less than 2 in.
